**DEPARTMENT OF TRANSPORTATION****DIVISION OF ENGINEERING SERVICES**

Contract #: 04-0120F4Cty: SF/ALA Rte: 80 PM: 13.2/13.9File #: 69.28**WELDING INSPECTION REPORT****Resident Engineer:**Pursell, Gary**Address:** 333 Burma Road**City:** Oakland, CA 94607**Report No:** WIR-002975**Date Inspected:** 10-Jun-2008**Project Name:** SAS Superstructure**OSM Arrival Time:** 700**Prime Contractor:** American Bridge/Fluor Enterprises, a JV**OSM Departure Time:** 1700**Contractor:** Zhenhua Port Machinery Company, Ltd (ZPMC), Changxing Island **Location:** Shanghai, China**CWI Name:** Sun Wei**CWI Present:** Yes No**Inspected CWI report:** Yes No N/A**Rod Oven in Use:** Yes No N/A**Electrode to specification:** Yes No N/A**Weld Procedures Followed:** Yes No N/A**Qualified Welders:** Yes No N/A**Verified Joint Fit-up:** Yes No N/A**Approved Drawings:** Yes No N/A**Approved WPS:** Yes No N/A**Delayed / Cancelled:** Yes No N/A**Bridge No:** 34-0006**Component:** OBG and Tower**Summary of Items Observed:**

**Production Monitoring Test Macro-Etch Samples**

**77M Partial Tower Mock-ups**

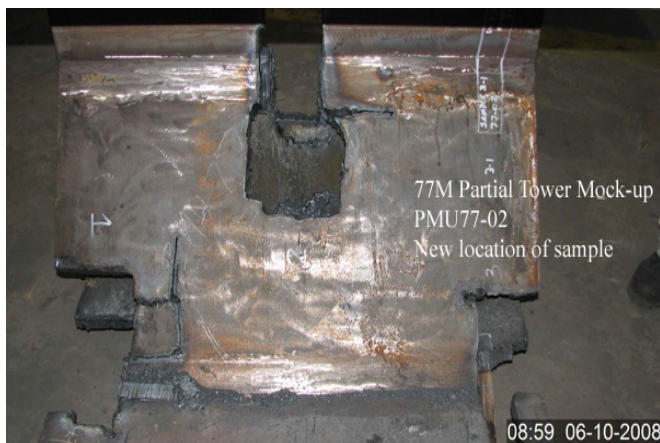
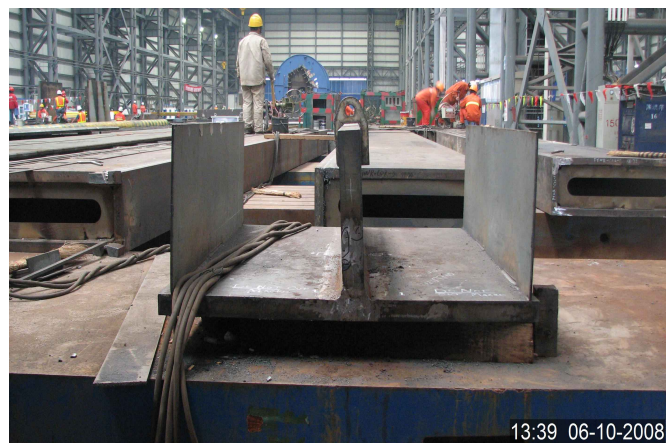
**Longitudinal Stiffener to Skin Plate WT-101**

The Quality Assurance Inspector observed the partial joint penetration welding was completed the previous shift. ABF Representative Mike Williams stated that due to welding the stiffener was distorted 10 millimeters, measuring from the top off the stiffener to the skin plate. In actuality the cause was not distortion at all. The Quality Assurance Inspector observed the skewed angle during the fit-up process as illustrated in the digital

photograph below taken on 6-4-2008. The other digital photograph taken on 6-10-2008 illustrates the approximate same skewed angle after welding.
